PAWTUXET RIVER BASIN
CRANSTON, RHODE ISLAND

CURRAN UPPER RESERVOIR DAM
RI 00702

PHASE 1 INSPECTION REPORT
NATIONAL DAM INSPECTION PROGRAM

MARCH 1980

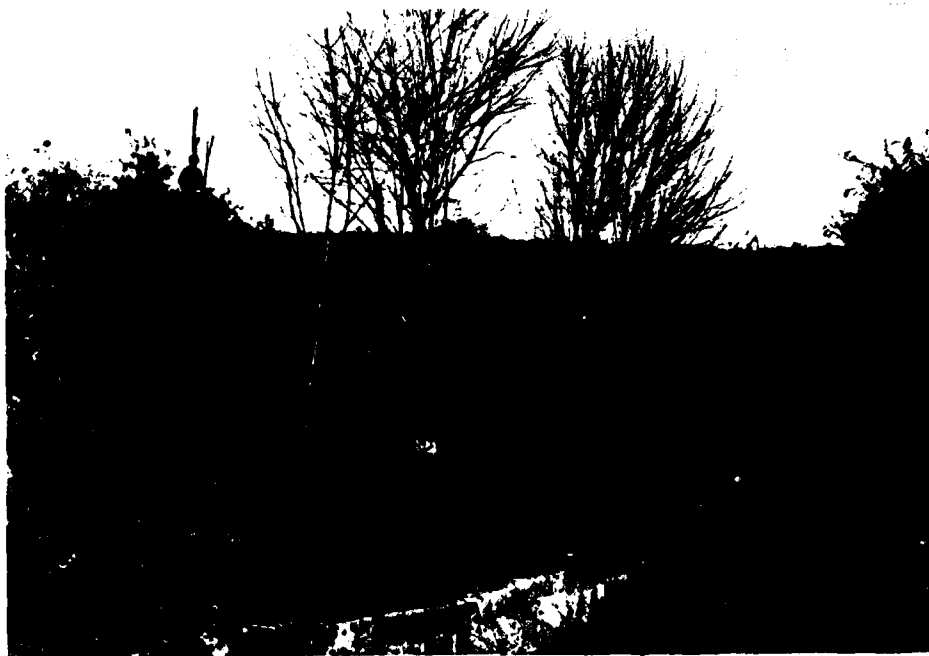
The downstream slope is overgrown with trees and bushes. Some of the larger trees can be seen in Photos C-3 and C-4. Access stairs have been built on the slope in two locations. Extensive seepage was observed at the toe of the slope primarily between Sta 8+00 and 9+00 and between Sta 3+00 and 5+50. In some of the seepage areas the lower footage of the slope appeared soft and wet, even though no seepage could be observed flowing out of the slope. The seepage exiting out of the toe could be observed after clearing the cover of leaves. (See Photo C-11). At about Sta 4+25, there is standing rust-colored water and vegetation typical of wet areas. The seepage flows downstream and to the right towards the outlet channel which is the natural streambed. Some animal burrows exist on the slopes (Photo C-15).

PHOTO C-3 Downstream slope of dam taken from right abutment

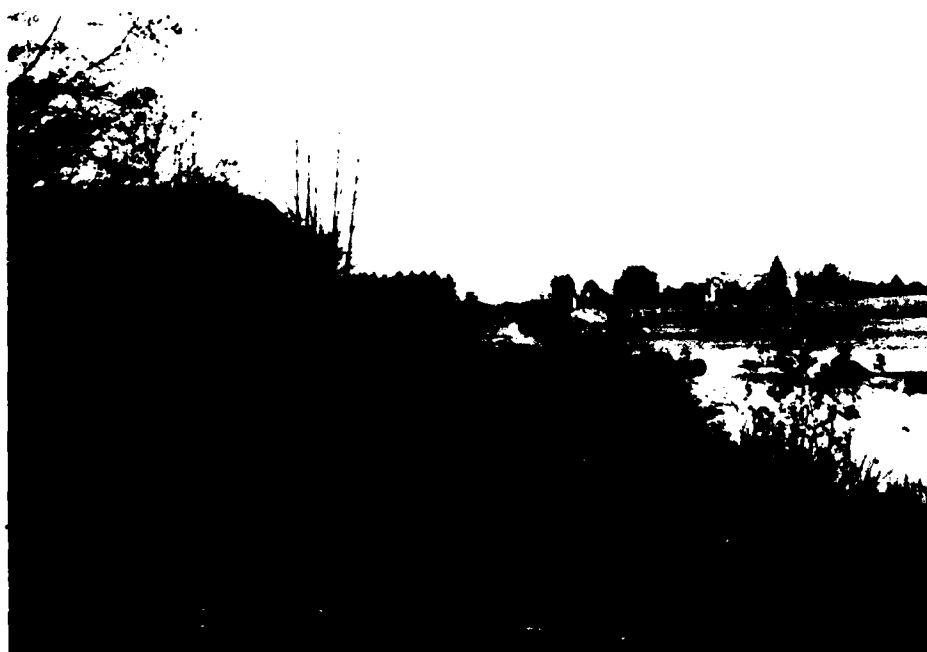
The upstream slope is heavily overgrown with bushes and saplings. It is generally covered with riprap (Photos C-1, 2), but in some areas the riprap is missing. In those areas, sloughing of the crest shoulder on the upstream slope of the dam has occurred. The crest is grass covered (Photos C-5, 6) and shows no signs of erosion.

PHOTO C-6 Crest of dam looking from right abutment
